Long-term success of electrical equipment installed at airports depends on corrosion prevention knowledge and defense of the original product specifications.

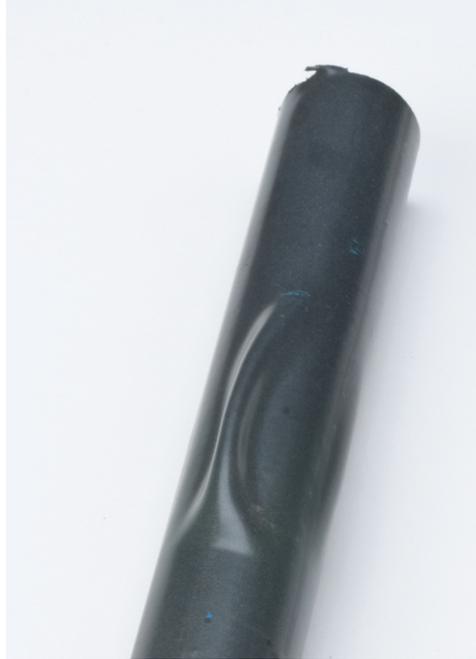
Photo Caption: The PVC coating has blistered due to poor adhesion of the coating to the substrate.

All chosen materials for the conduit should be able to withstand exposure to corrosive elements as well as exposure to chemical properties. Protective coatings prevent the chemical action of corrosion by blocking electrolytes from the anode, cathode, and metallic path, which are often on the same piece of material. In severely corrosive environments, galvanized steel is often coated with an additional paint or polymer coating, such as PVC, for even stronger corrosion protection. However, it is important to choose a superior coated product as many coatings fail in the field due to poor adhesion to the metal.

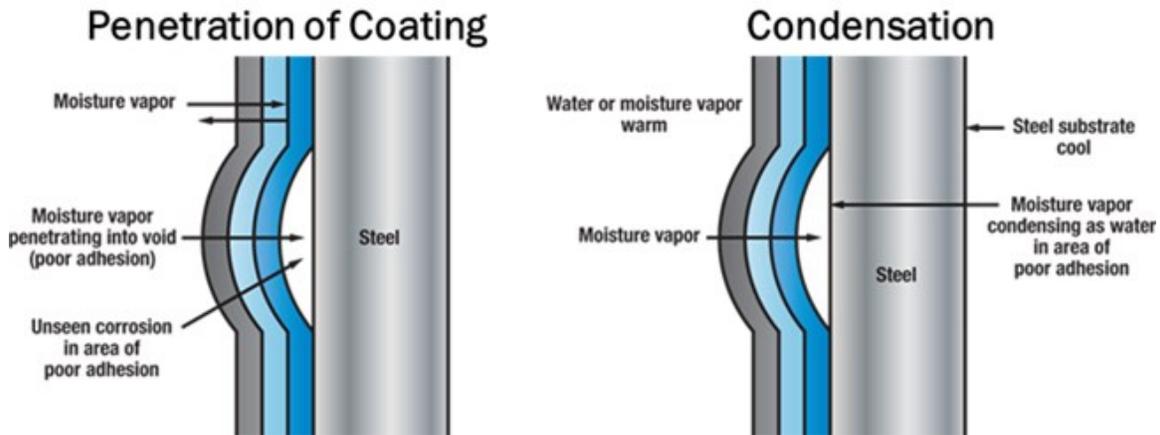
For PVC coatings to properly adhere to a galvanized zinc surface, proper preparation of the surface is a must. Sherwin Williams states that approximately 80 to 90 percent of premature coating failures are caused by improper or inadequate surface cleaning and preparation.⁵ As seen in the figure below, without proper coating adhesion, often times, the corrosive elements become trapped underneath the coating and are held up against the substrate, accelerating the rate of corrosion.
